Fire Risk Assessment Report

**Alleyn's School
Townley Road
Dulwich
London
SE22 8SU**

Issue Date: 01/09/2023

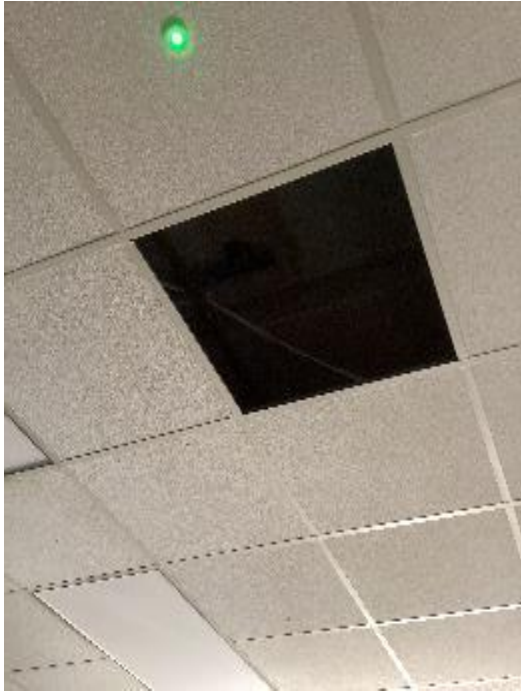
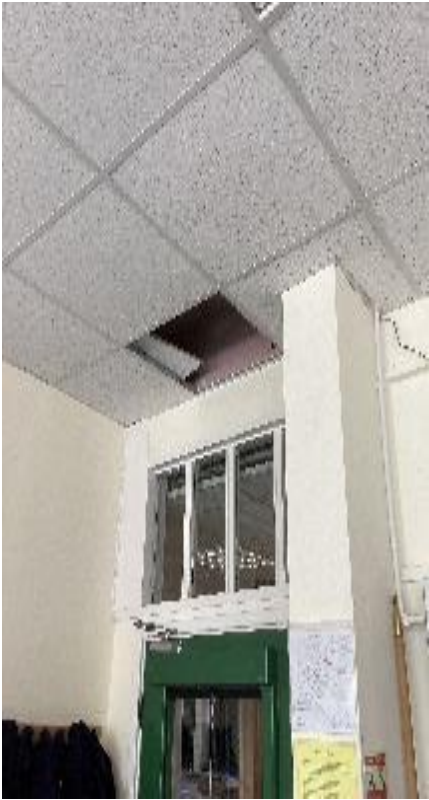
3.12.10	Are corridors in excess of 12 metres long, provided with at least one set of fire doors to subdivide the corridor?	Satisfactory
Comments and Hazards Observed: 3.12.4 There are areas throughout the school where ceiling tiles are missing or incorrectly fitted. All tiles must be fitted correctly so as to provide Compartmentation

Missing Ceiling Tile	Missing Ceiling Tile

Main Building				
Item Ref	Priority	Recommended Action	Target Date	Completed (Y / N)
3.15.2	Medium	Ease and adjust fire doors. Refit or replaced missing ceiling tiles.	Within two months

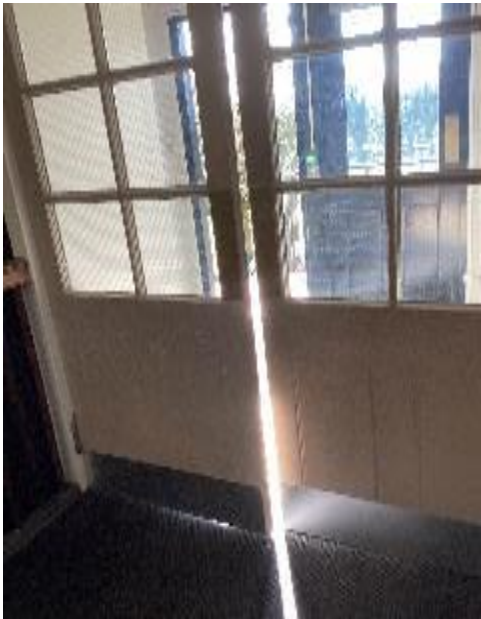
Fire Doors requiring adjusting throughout	Fire Doors wedged open.

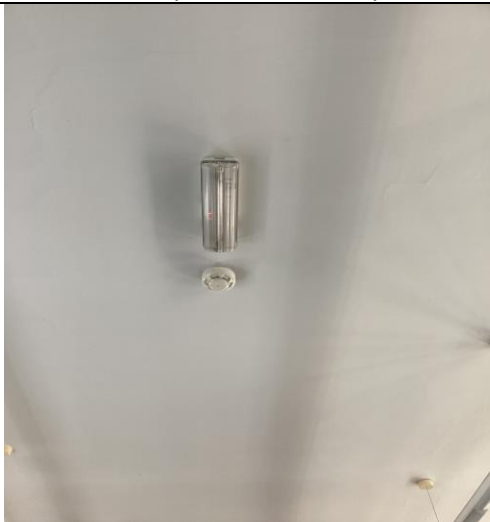
<p>Faulty EL In the Library</p>

Sixth Form Centre & Library				
Item Ref	Priority	Recommended Action	Target Date	Completed (Y / N)
Additional Fire Directional signage is required. Address issues with the emergency lighting

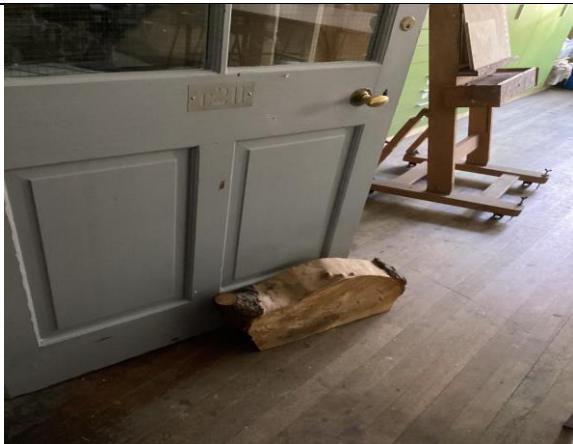
<p>Main Building- Fire Doors wedged open</p>

Music School				
Item Ref	Priority	Recommended Action	Target Date	Completed (Y / N)
Fire doors are being wedged open. All fire doors must remain closed when not in use unless fitted with a mechanical lock or fitted with a working door guard system.

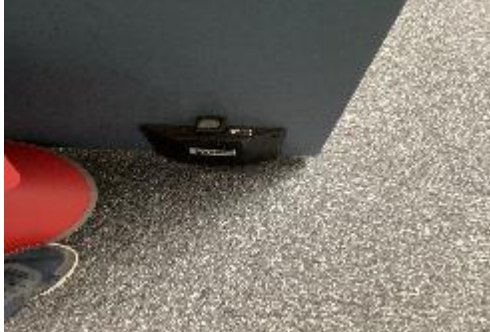
<p>Main Building Fire Door wedge open Door guard not working correctly</p>
